TWR-17371

Space Shuttle Development Motor No. 9 (DM-9) Final Test Report

September 1990

Thiokol CORPORATION
SPACE OPERATIONS

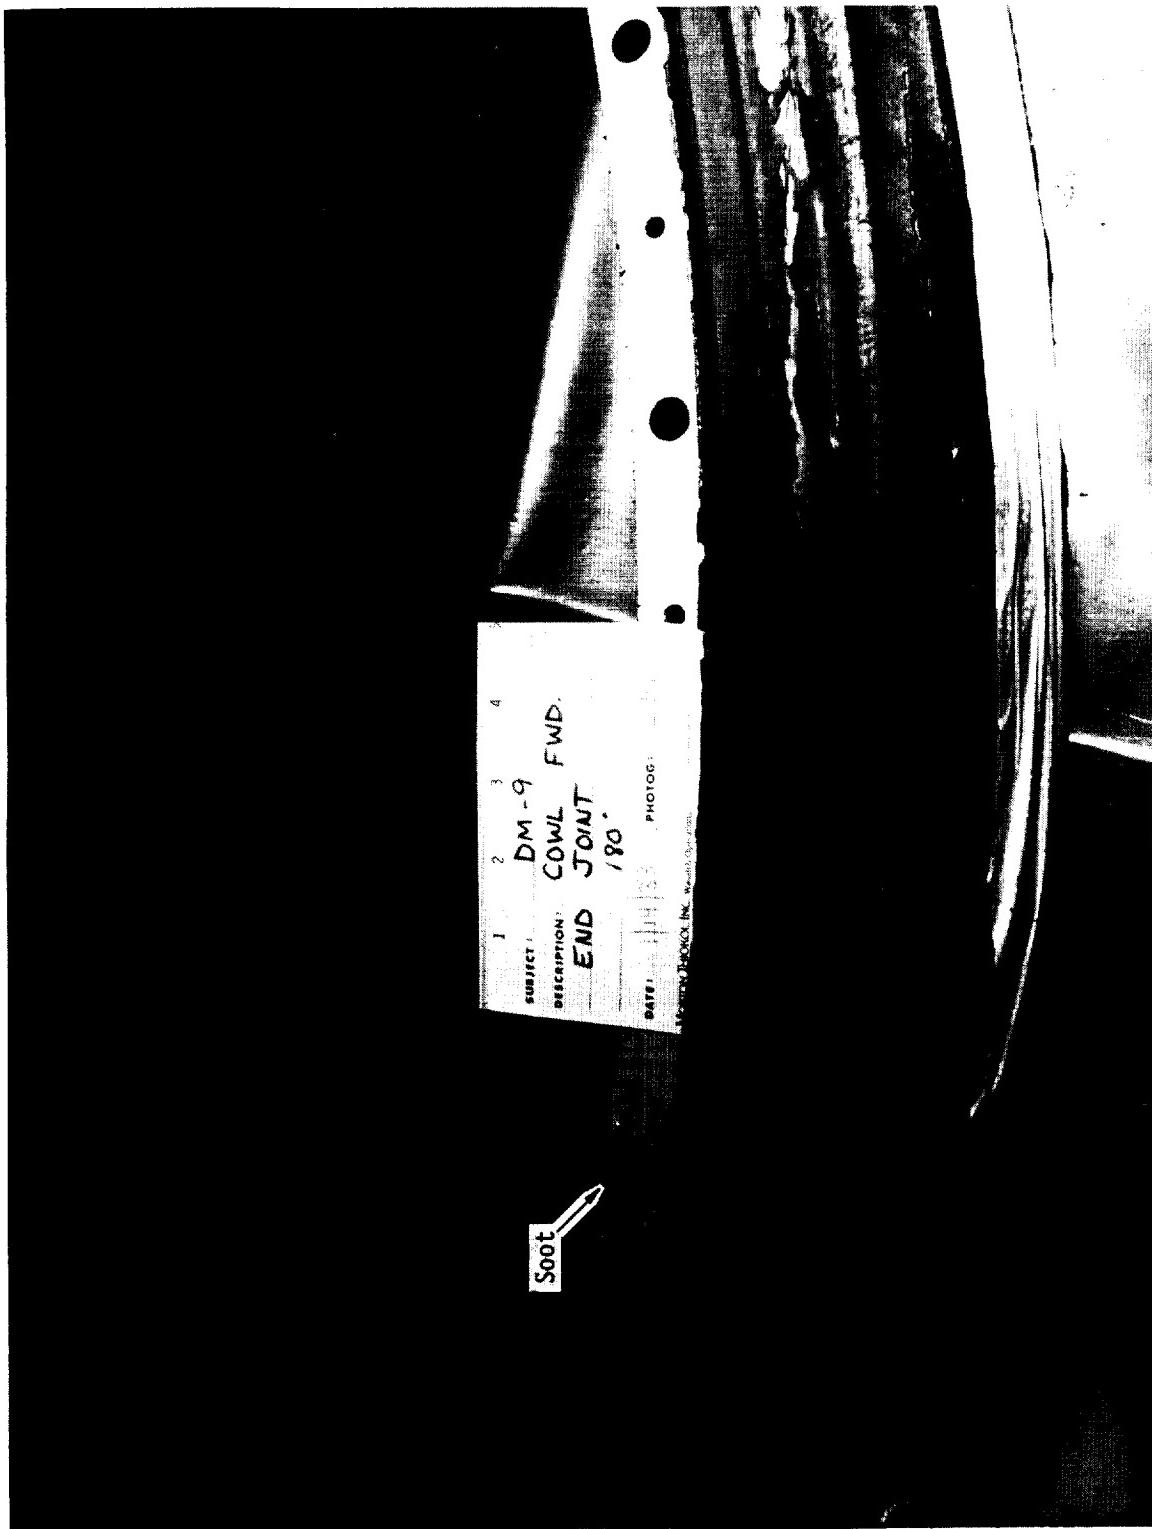
Figure 7.5-90. Cowl Forward End Joint at 180 deg

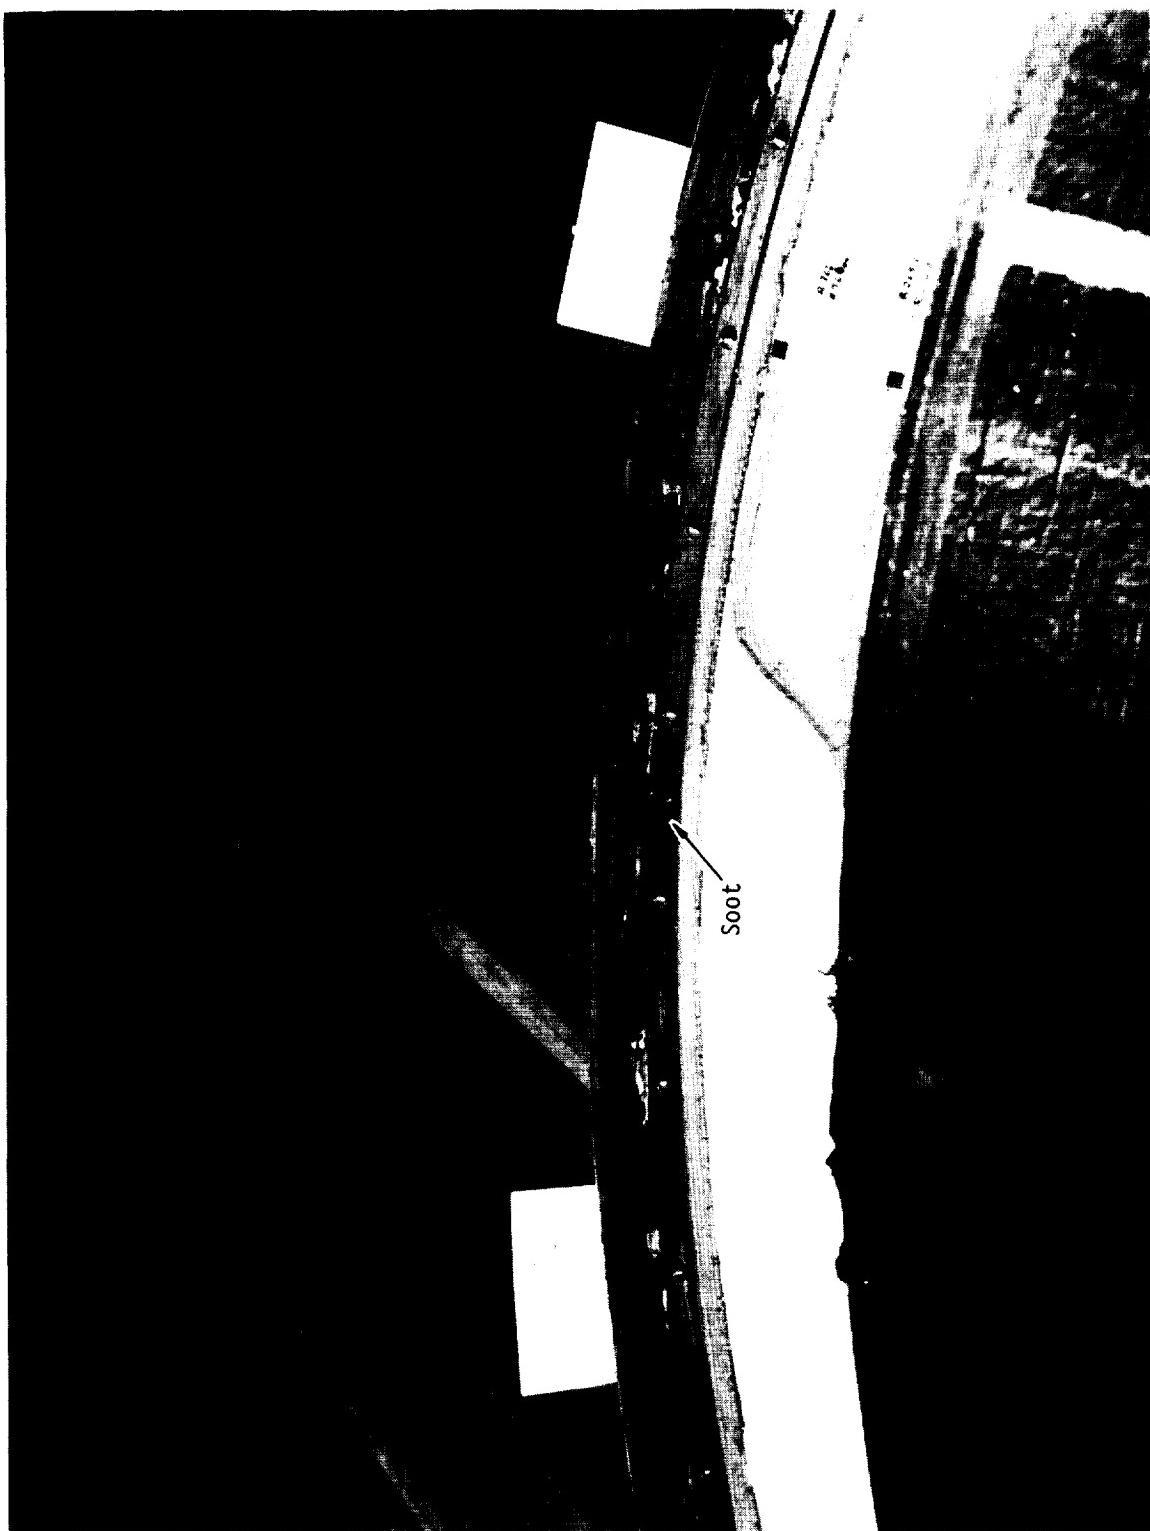
Figure 7.5-91. Nose Cap Aft End at 0-30 deg

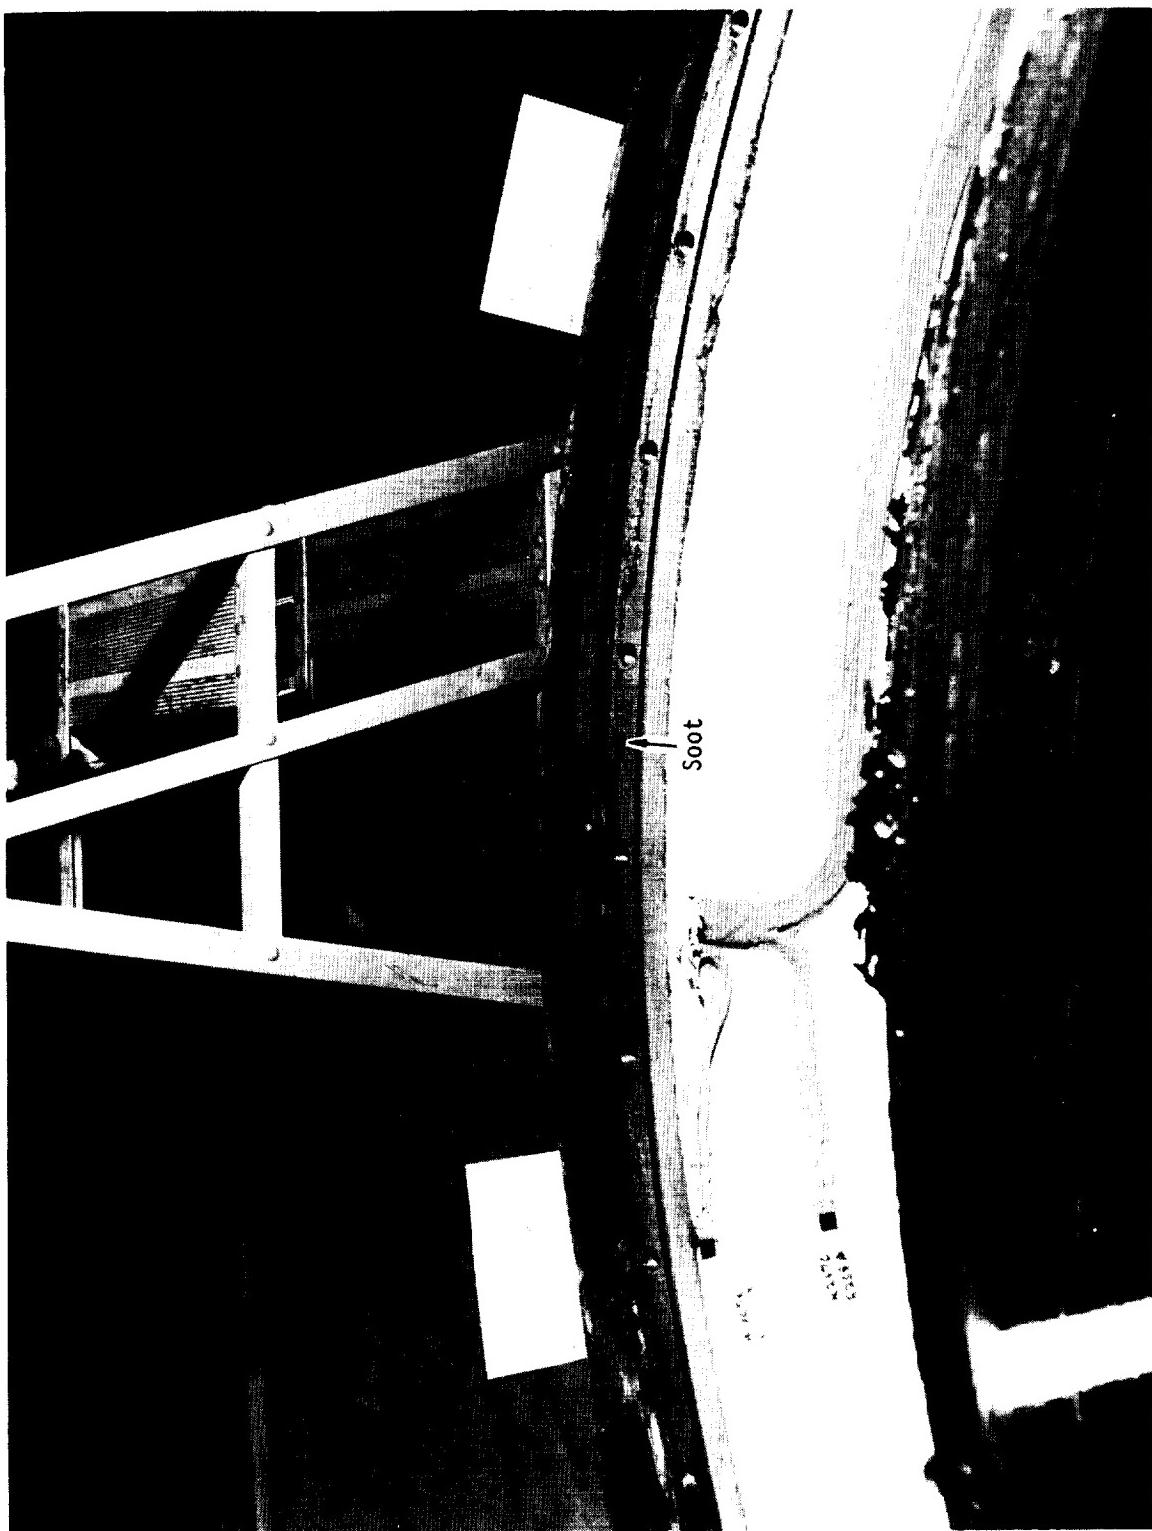
Figure 7.5-92. Nose Cap Aft End at 60 to 90 deg Showing Soot

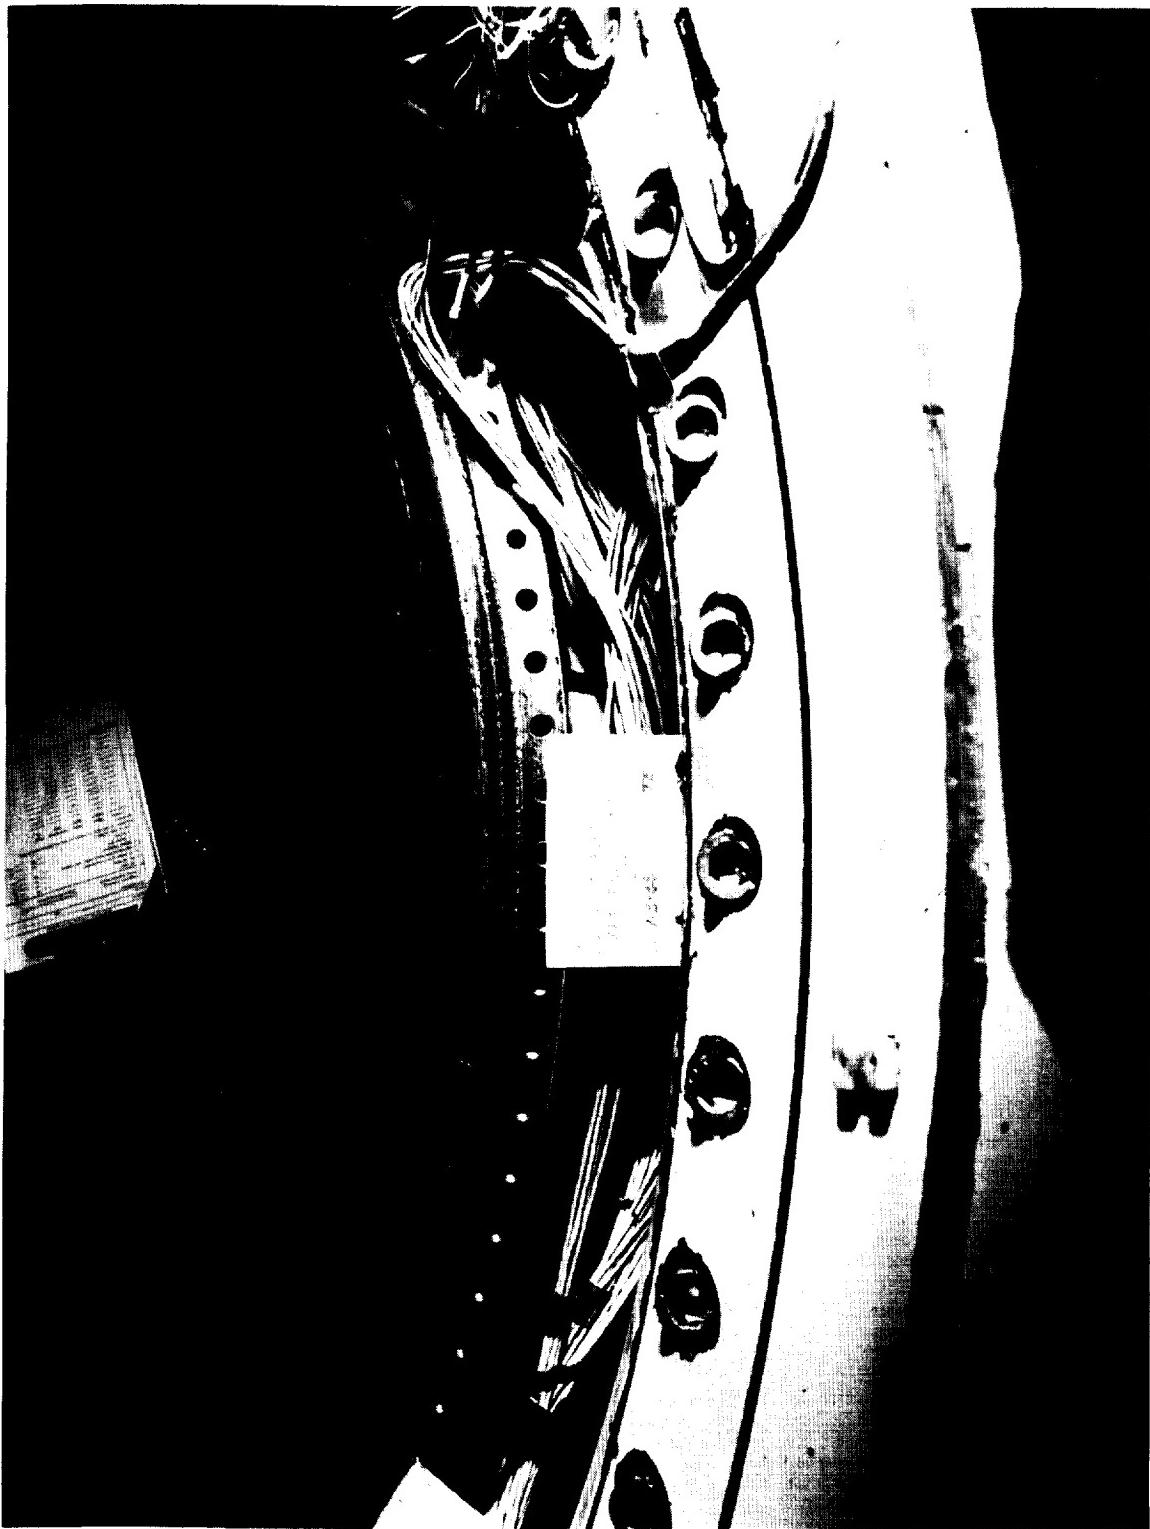
Figure 7.5-94. Throat Aft End Joint at 60 deg

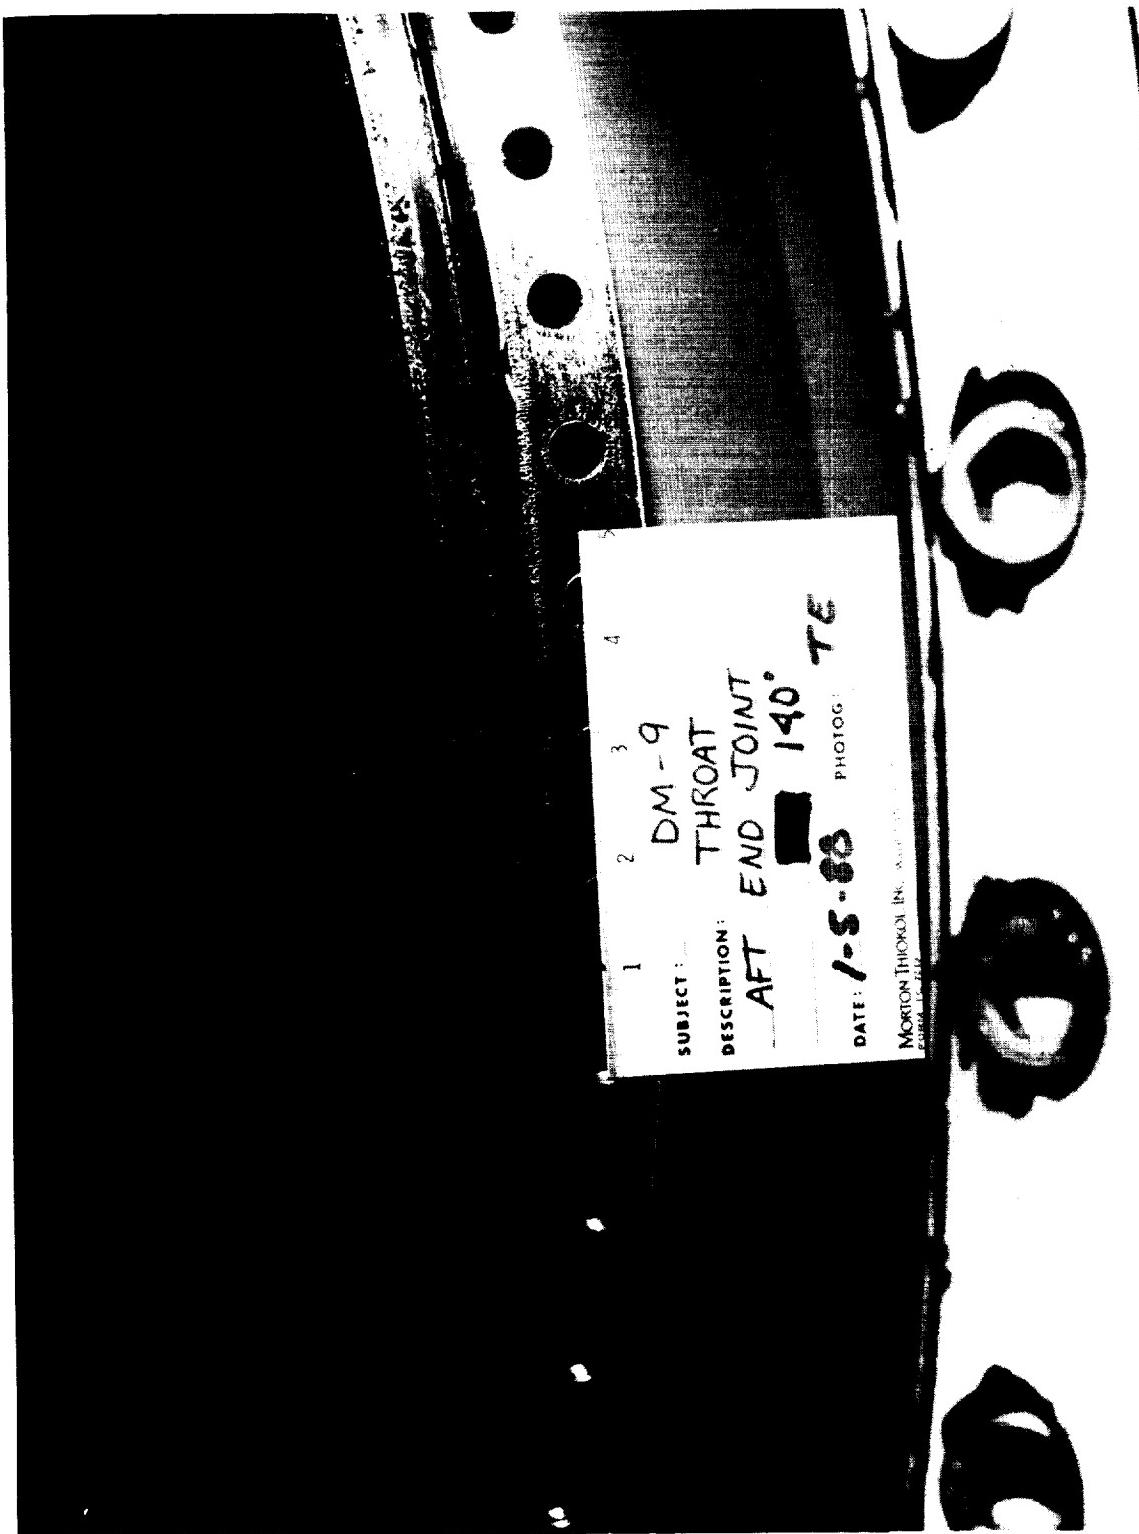
Figure 7.5-95. Throat Aft End Joint at 140 deg Showing Blowpath and Unfilled Area

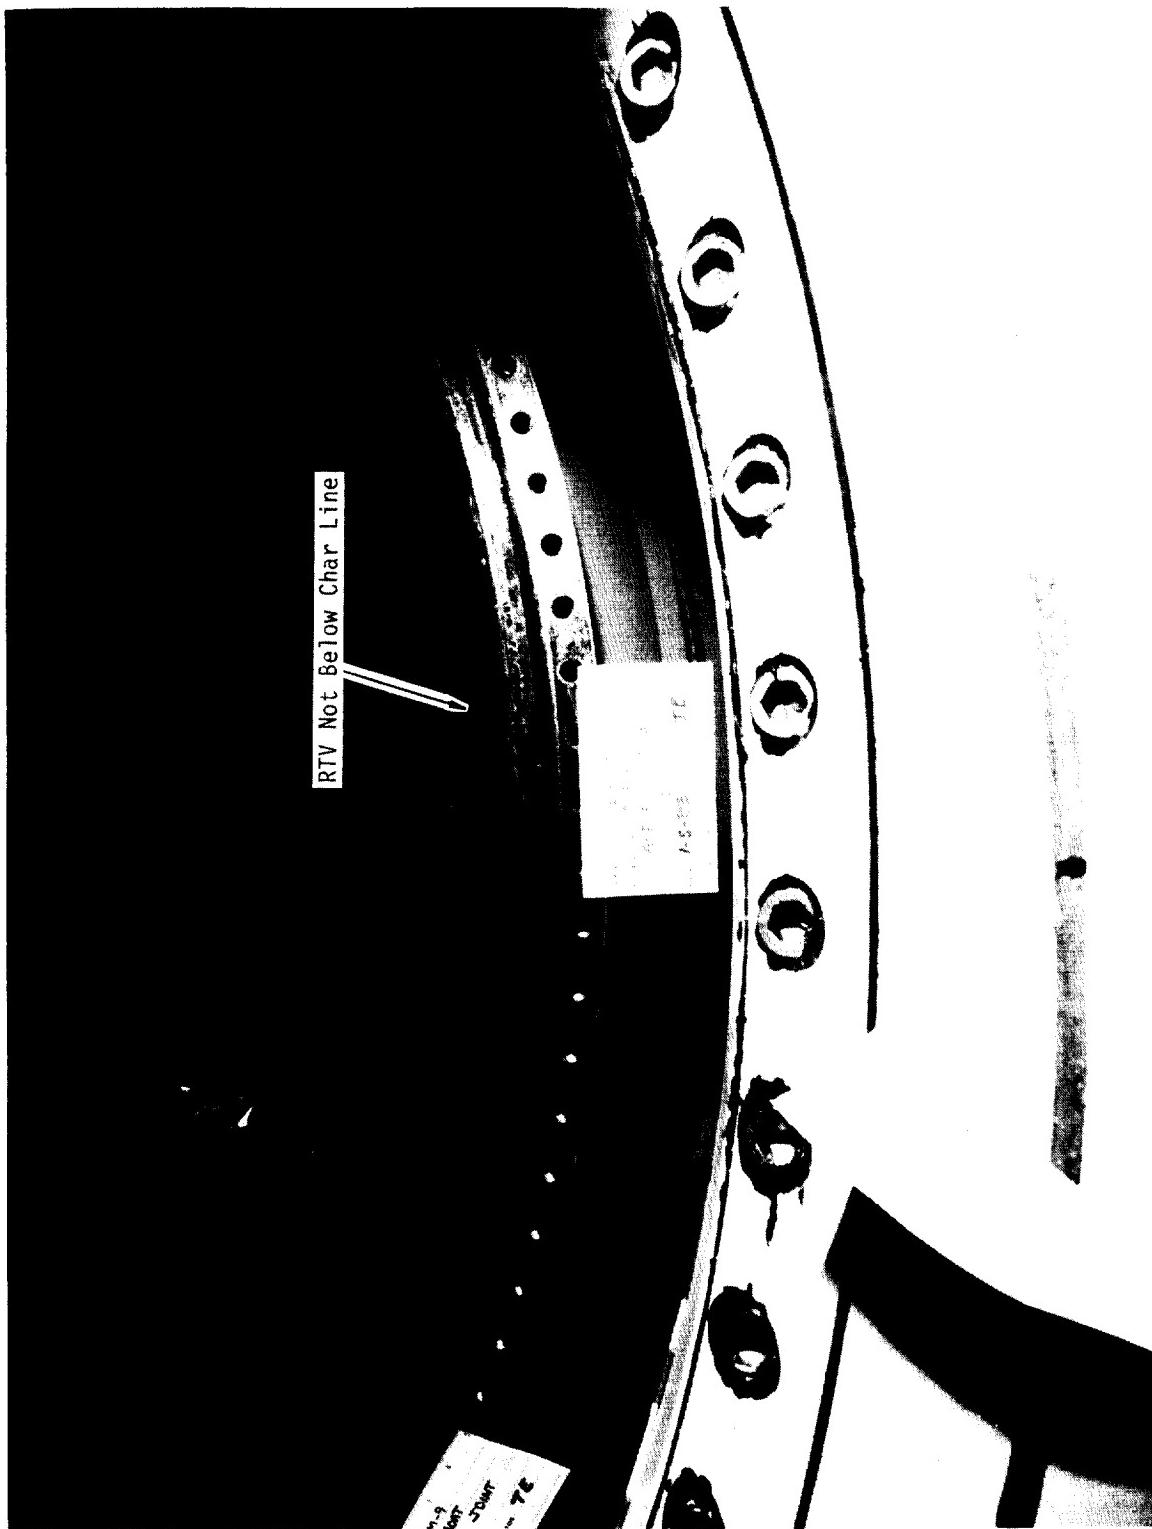
Figure 7.5-96. Throat Aft End Joint at 330 deg

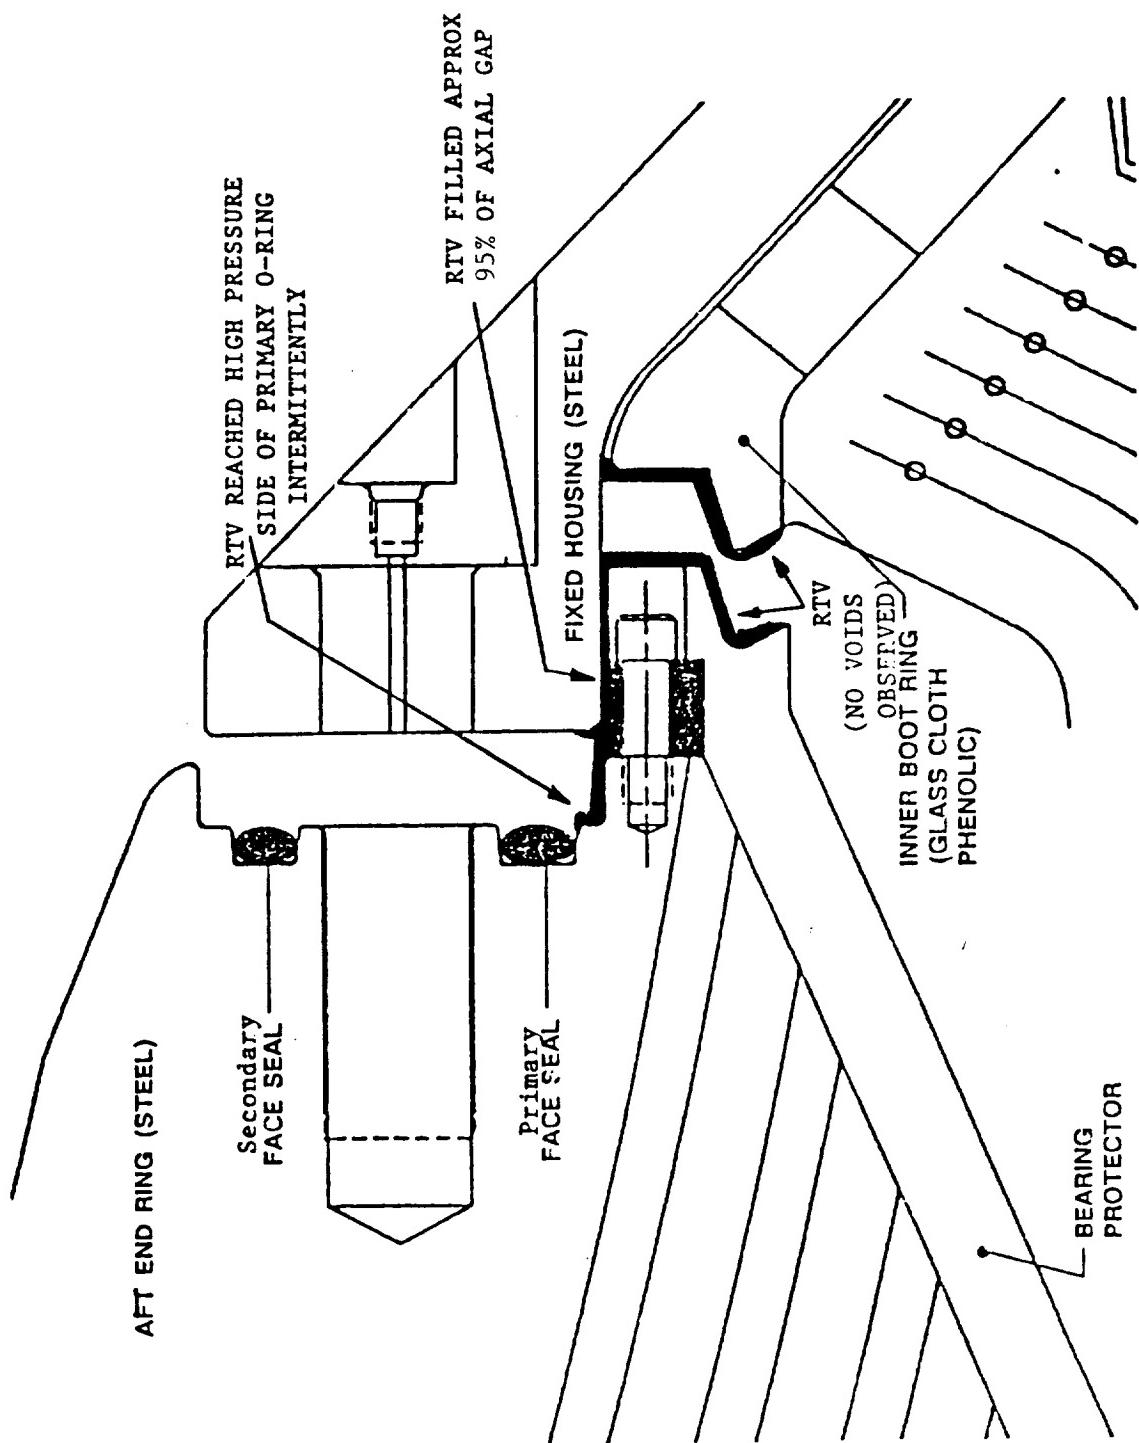
RTV sealant completely filled the bondline between the bearing protector and inner boot ring. No voids were observed in the RTV. Approximately 95 percent of the axial gap between the bearing protector and steel fixed housing was filled with sealant. RTV reached the high-pressure side of the primary O-ring from 40 to 112, 150 to 170, 220 to 250, 260 to 270, 275 to 318, and 350 to 355 deg. Sealant did not extrude past the O-ring. There was no assembly, disassembly, or heat effect damage observed on the primary O-ring, and the joint was free of soot. Inspection of the secondary O-ring revealed 12 diagonal abrasion marks between 218 and 227 deg. The marks were a maximum length of 0.05 in. and were approximately 0.001 to 0.002 in. deep.

Figure 7.5-98. DM-9 Post-Test Fixed Housing/Bearing Aft End Ring Joint

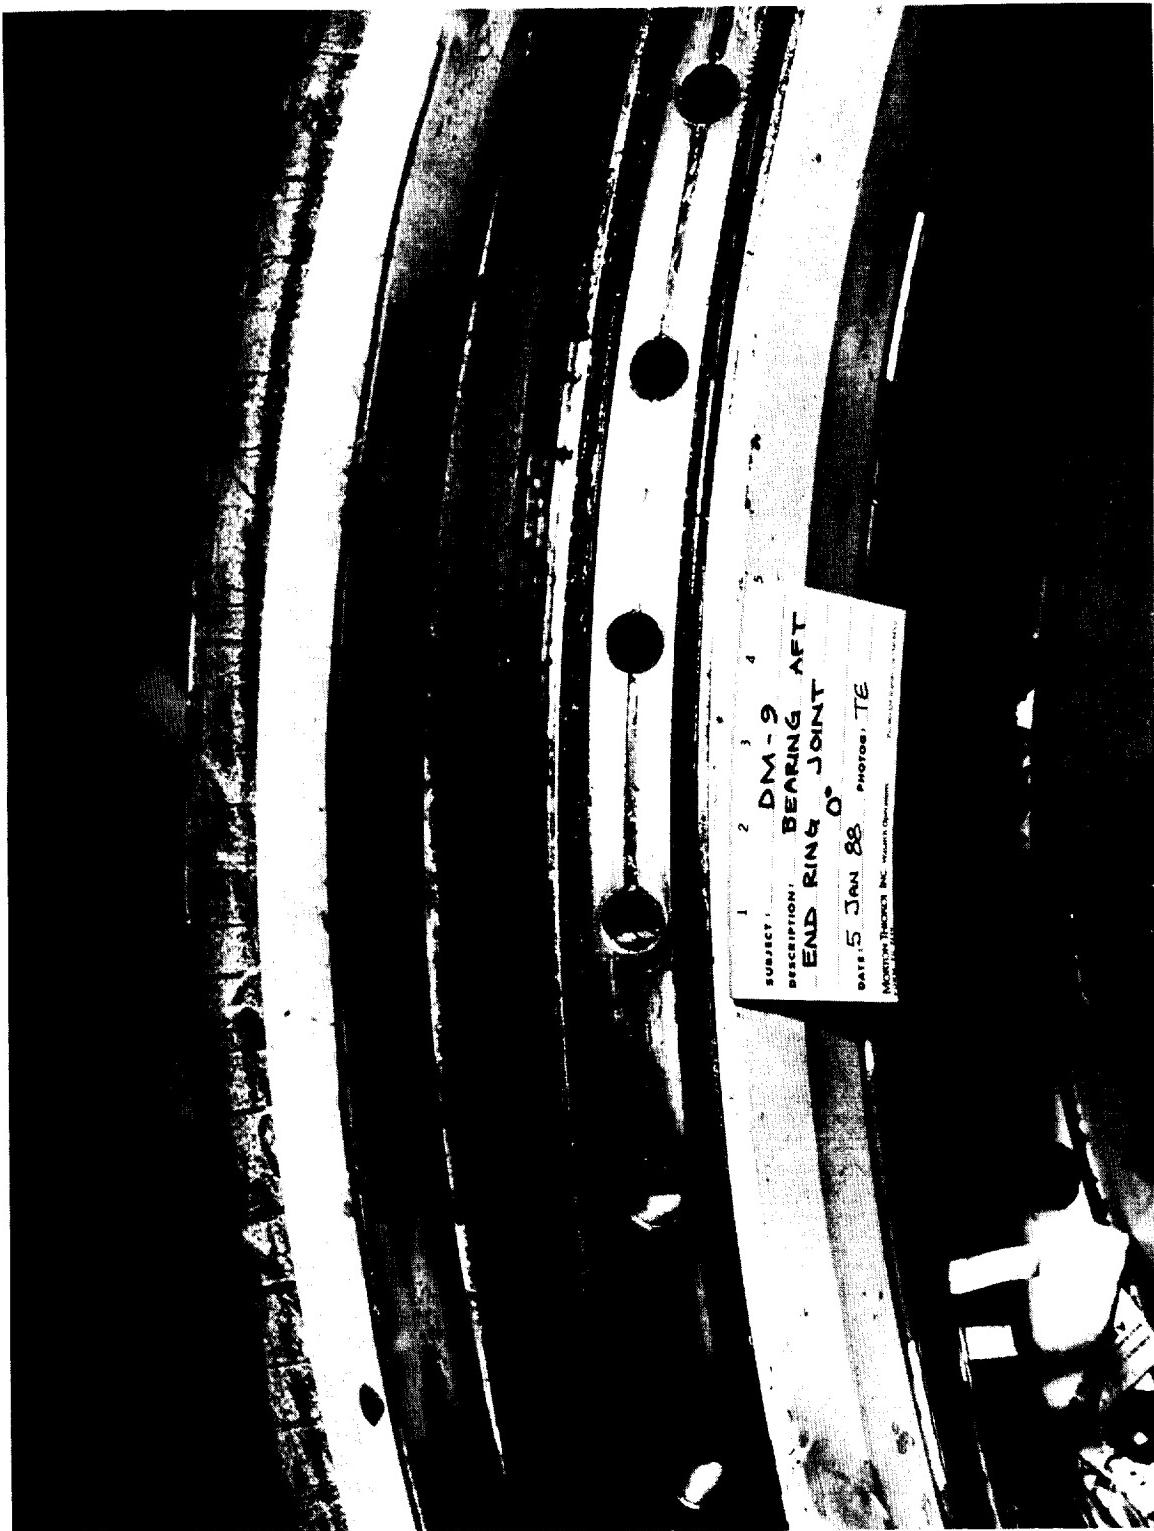
Figure 7.5-99. Bearing Aft End Ring Joint at 0 deg

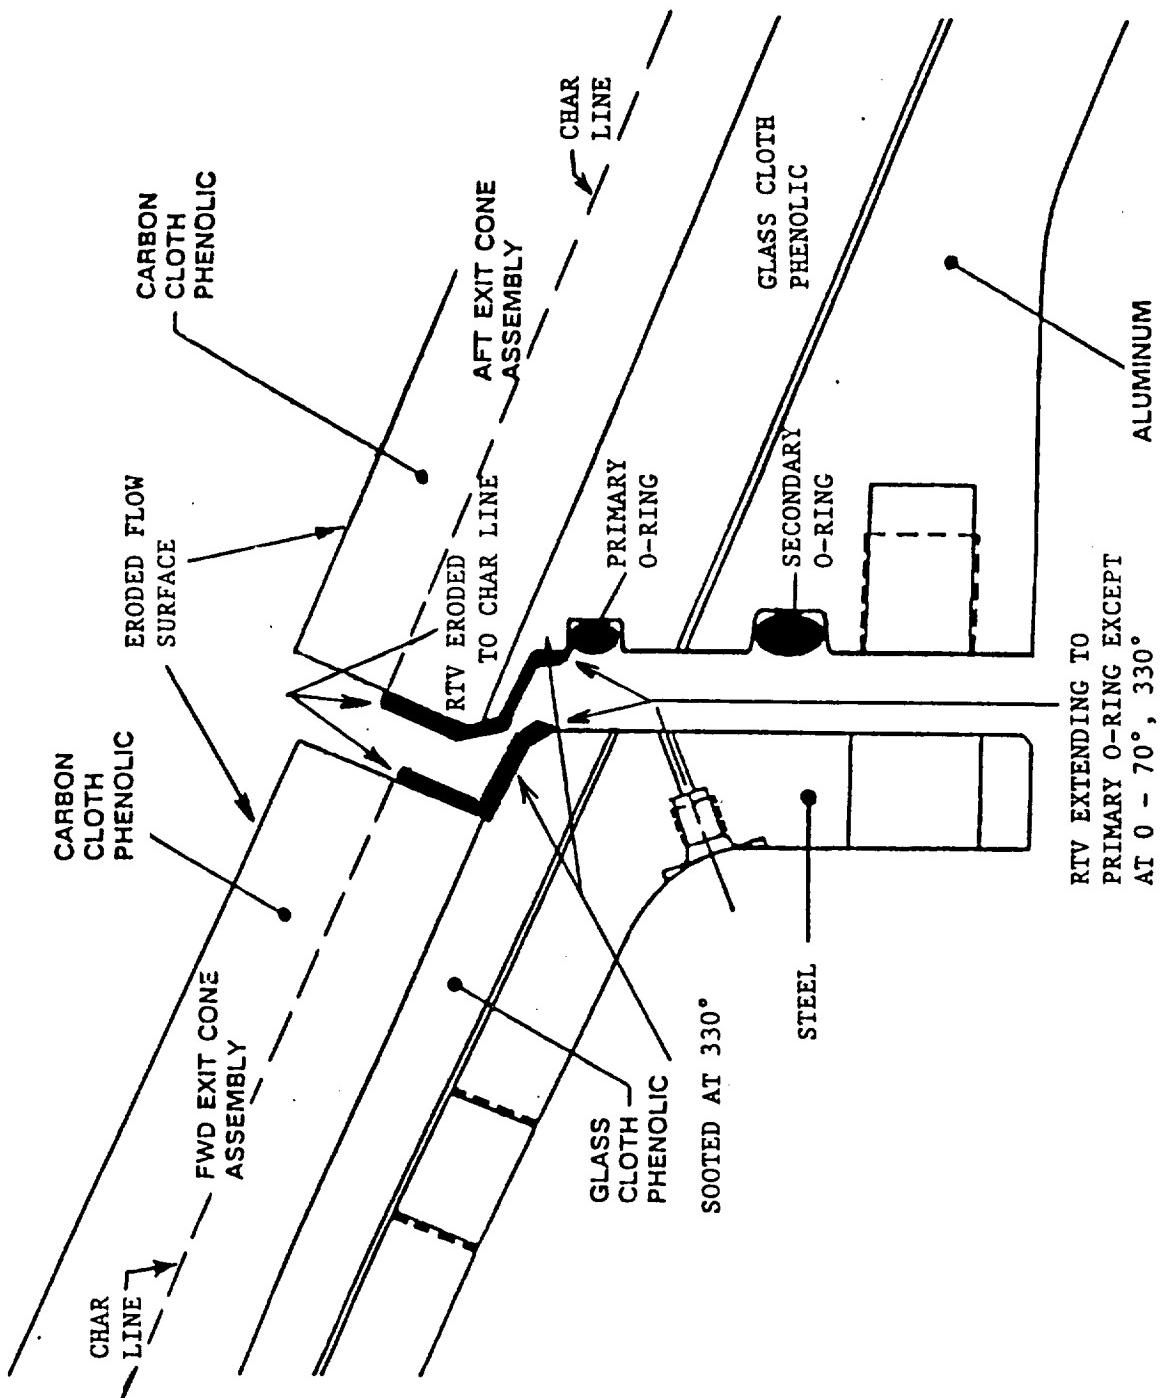
Figure 7.5-101. DM-9 Post-Test Forward Exit Cone/Aft Exit Cone Joint

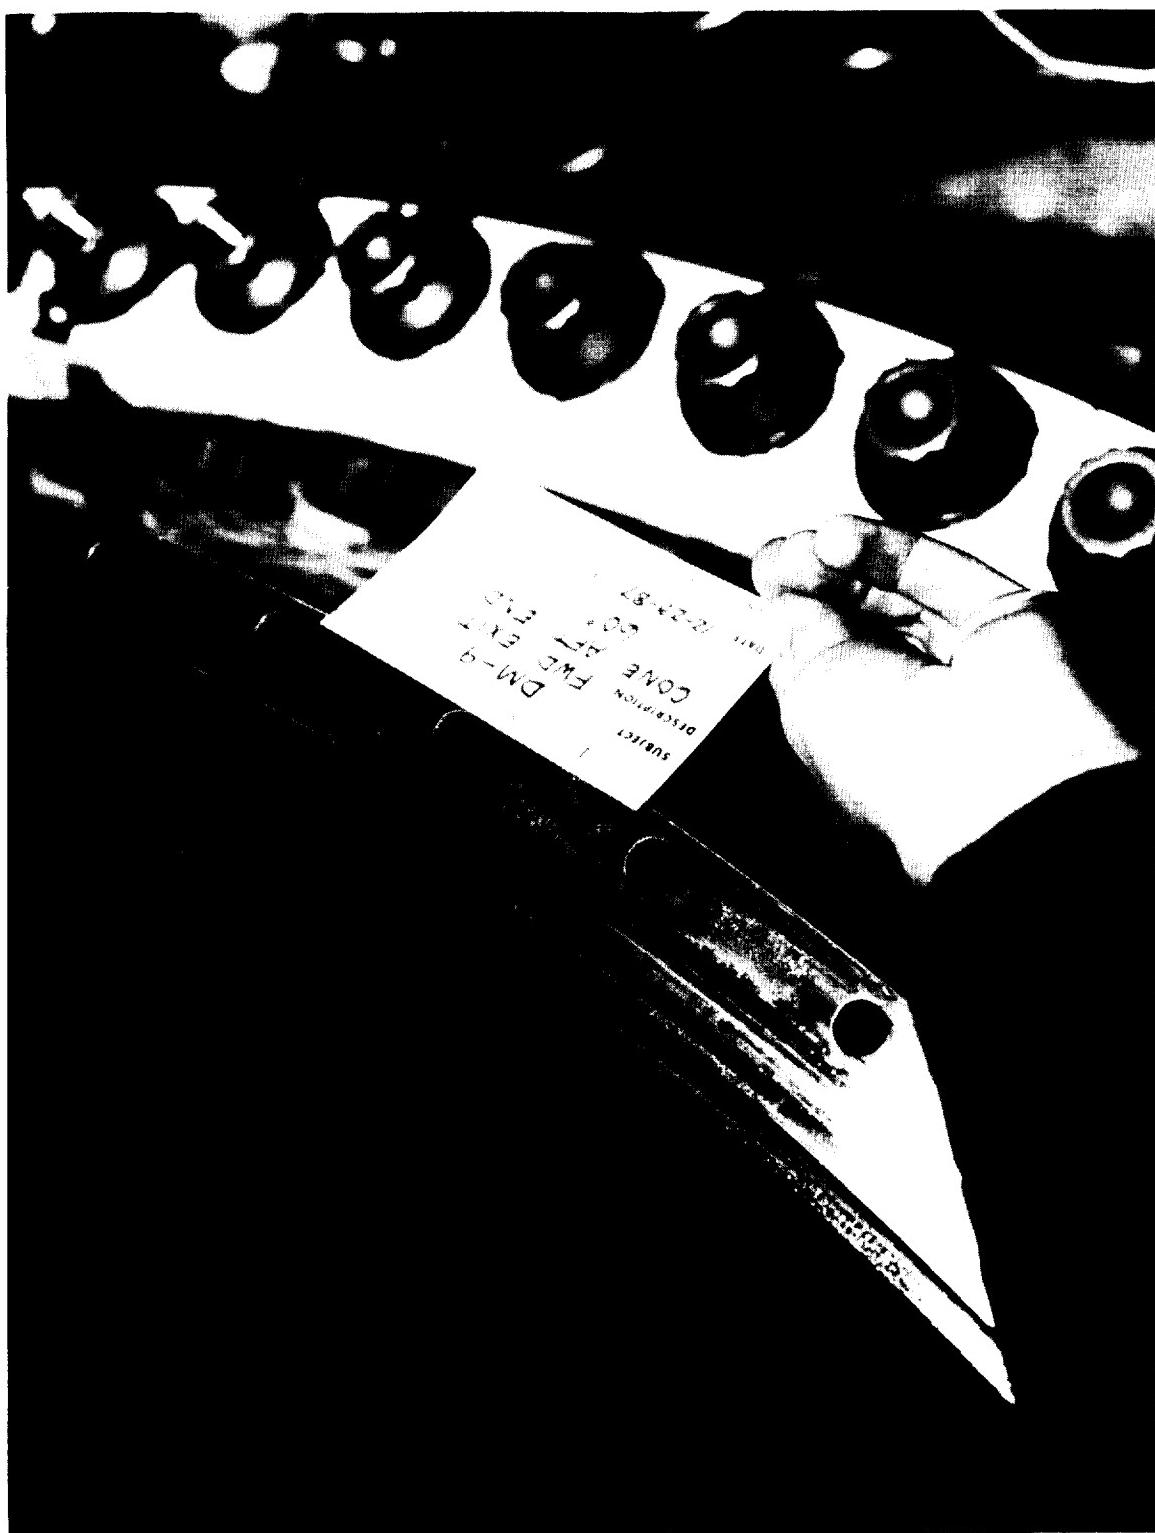
Figure 7.5-102. Forward Exit Cone Aft End at 60 deg

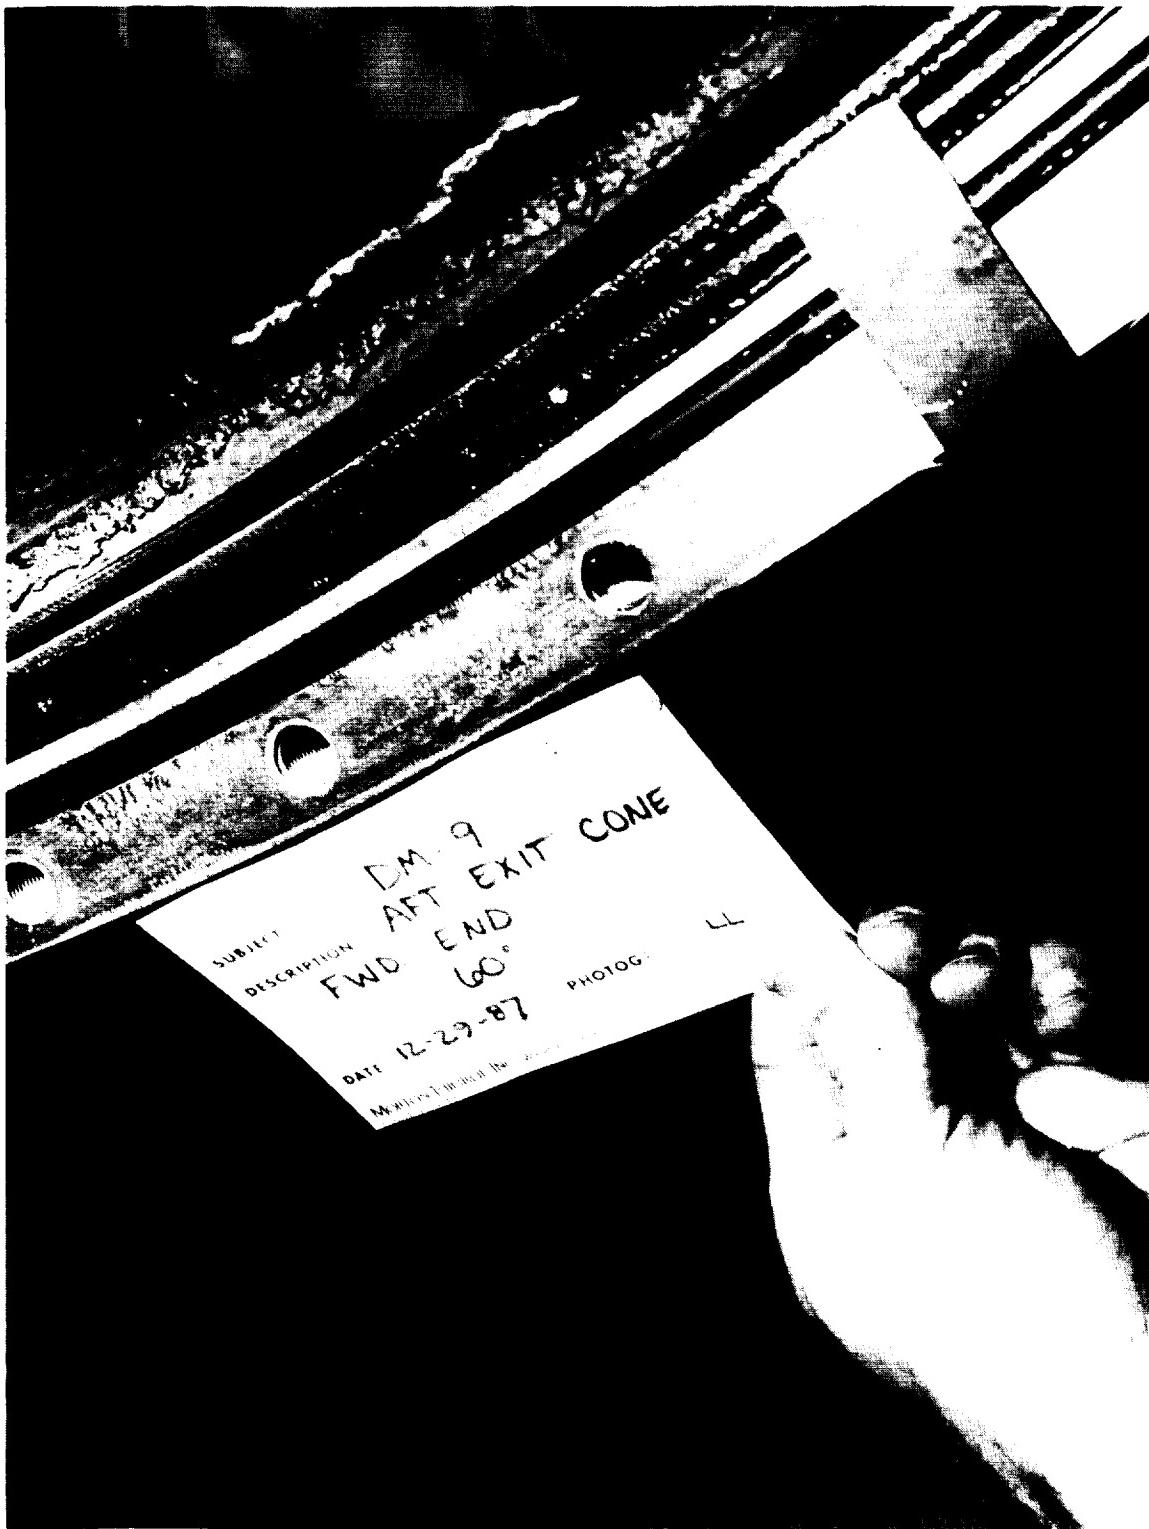
Figure 7.5-103. Aft Exit Cone Forward End at 60 deg

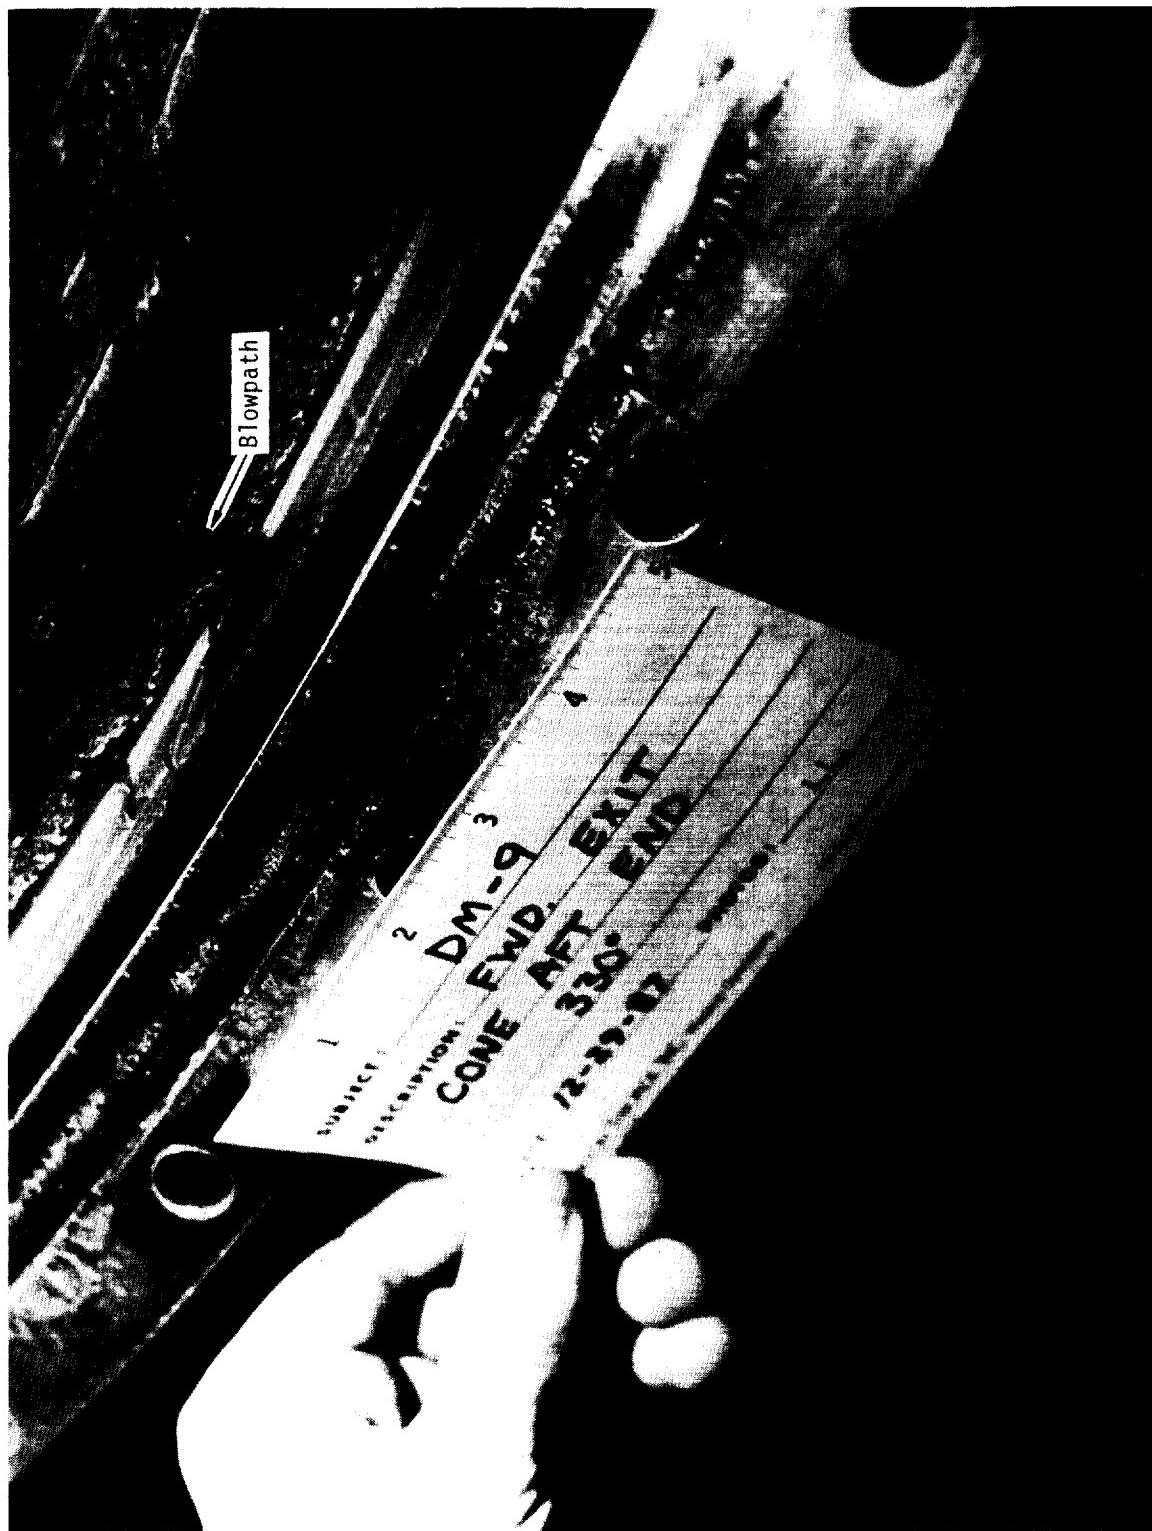
Figure 7.5-104. Forward Exit Cone Aft End at 330 deg Showing Blowpath

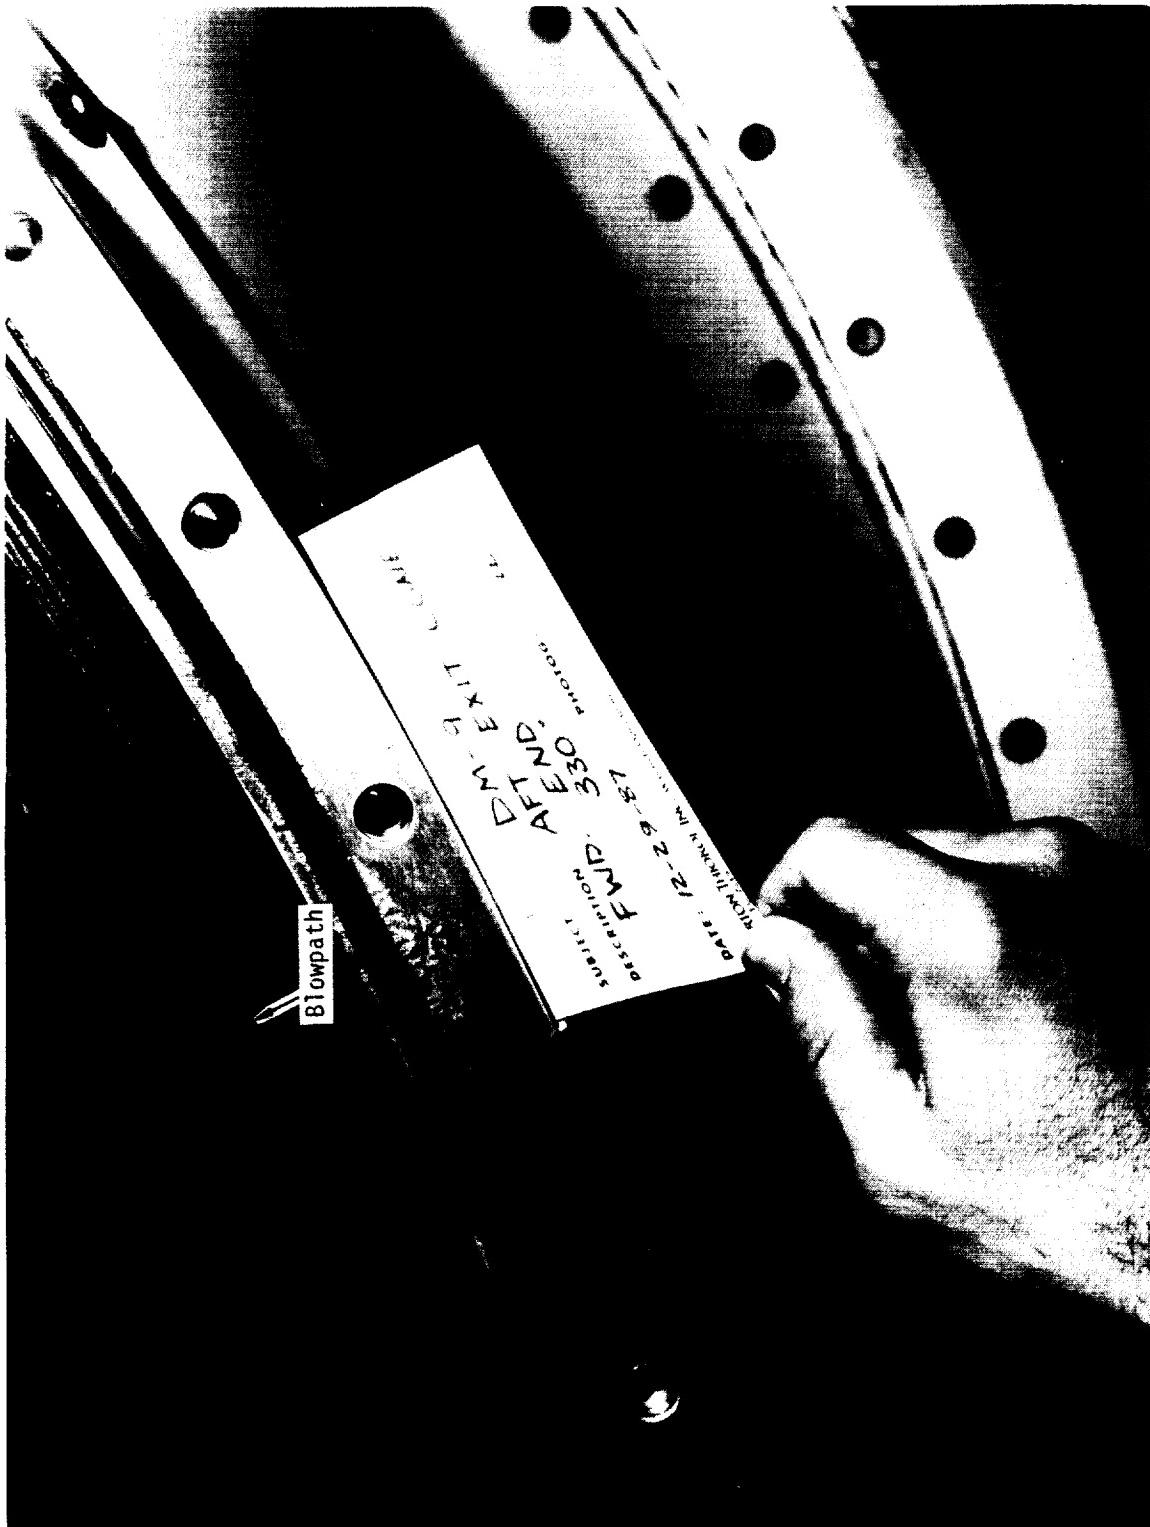
Figure 7.5-105. Aft Exit Cone Forward End at 330 deg Showing Blowpath
